**SITE ASSESSMENT REPORT
FOR
GHR FOUNDRY SITE
DAYTON, MONTGOMERY COUNTY, OHIO
TDD: S05-9604-004
PAN: 6A0401SIXX**

AUGUST 26, 1996

**UNITED STATES ENVIRONMENTAL PROTECTION AGENCY
Emergency Response Branch
77 West Jackson Boulevard
Chicago, Illinois 60604**

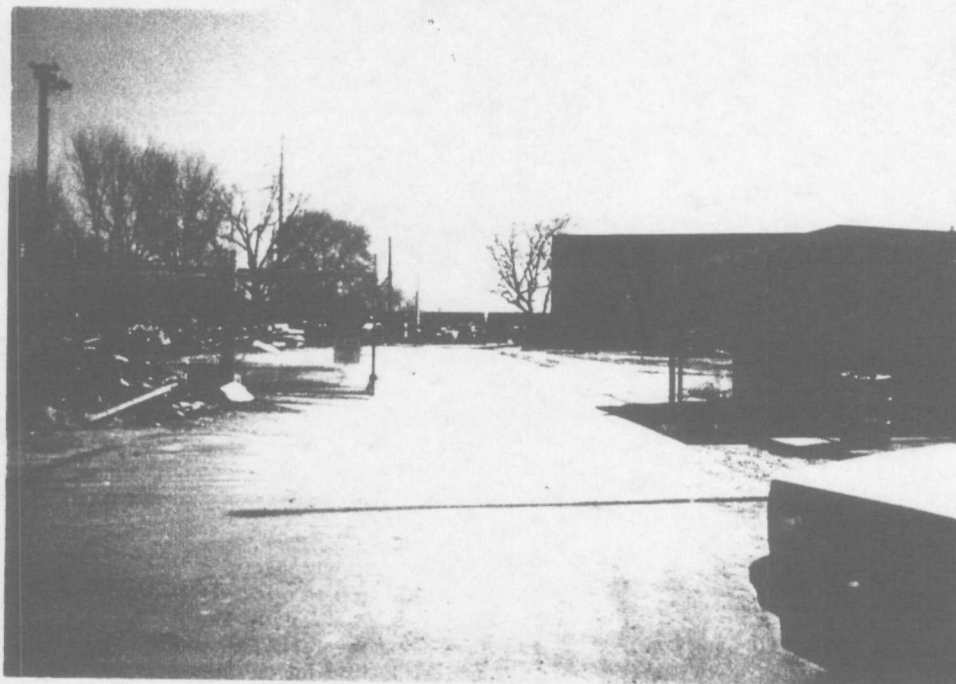
SITE NAME GHR FOUNDRY
 TDD # S05-9604-004
 DATE APRIL 10 1996
 TIME 1115
 DIRECTION E
 PHOTOGRAPHER LARRY LUECK

SUBJECT: Site front gate access road
 and guard shack (r)

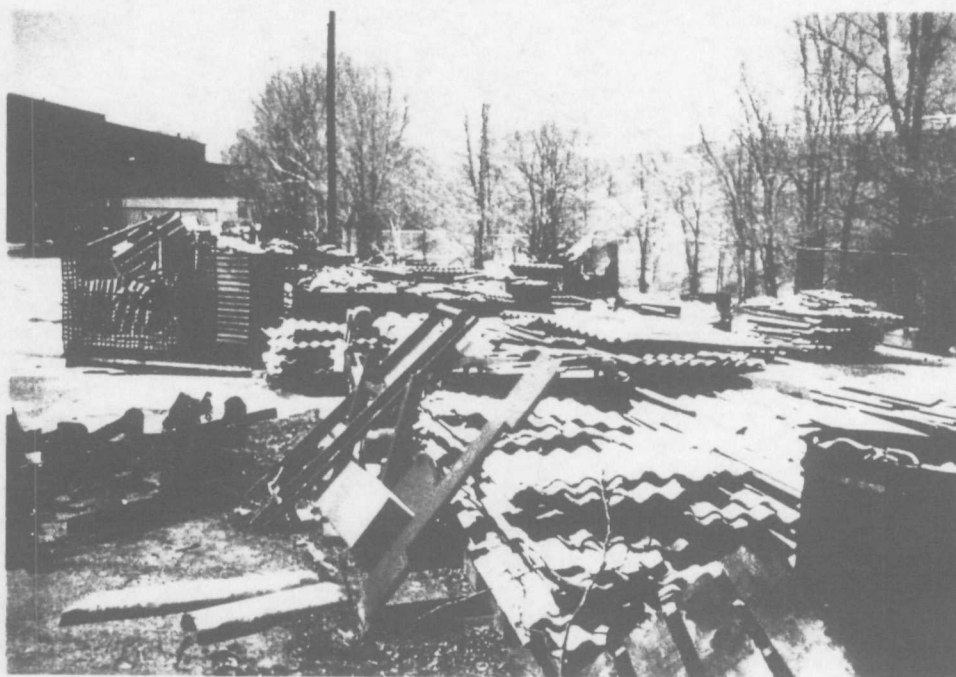
SITE NAME GHR FOUNDRY
 TDD # S05-9604-004
 DATE APRIL 10 1996
 TIME 1120
 DIRECTION WNW
 PHOTOGRAPHER LARRY LUECK

SUBJECT: Stacks of probable transite;
 expressway (r); front site fence
 in background; access road (l)

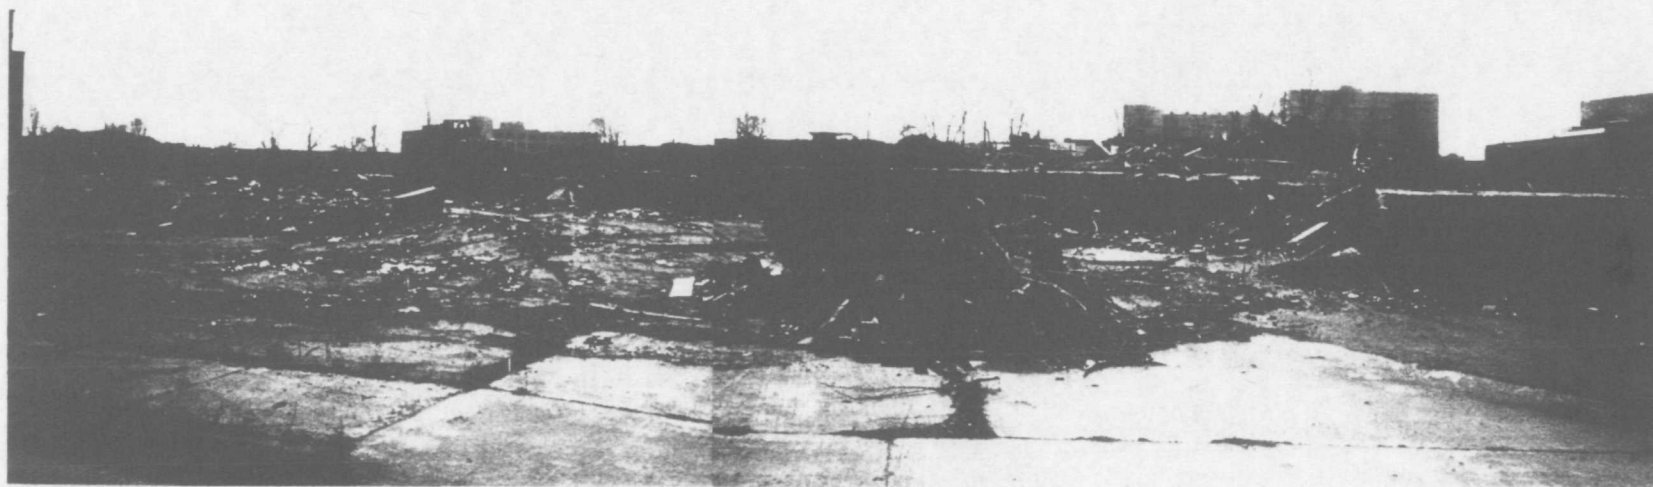
SITE NAME GHR FOUNDRY
TDD # S05-9604-004
DATE APRIL 10 1996
TIME 1115
DIRECTION SE to S
PHOTOGRAPHER LARRY LUECH

An operator with a small bulldozer appeared to be leveling 20 or more truckloads of soil over the southwest portion of the site, and numerous additional loads were delivered to the site during the site assessment. In the early afternoon, the OSC and START encountered Bill Caldwell of Sunesis Construction Company (Sunesis) on site, who said Sunesis is widening a road in another part of Dayton and bringing clean fill to the GHR Foundry site at the site owner's request. The bulldozer and operator spreading the fill around the southwest portion of the site, as well as the trucks delivering the clean fill, all belonged to Sunesis.

SUBJECT Dozer leveling recently delivered fill
dirt in southwest quadrant of site

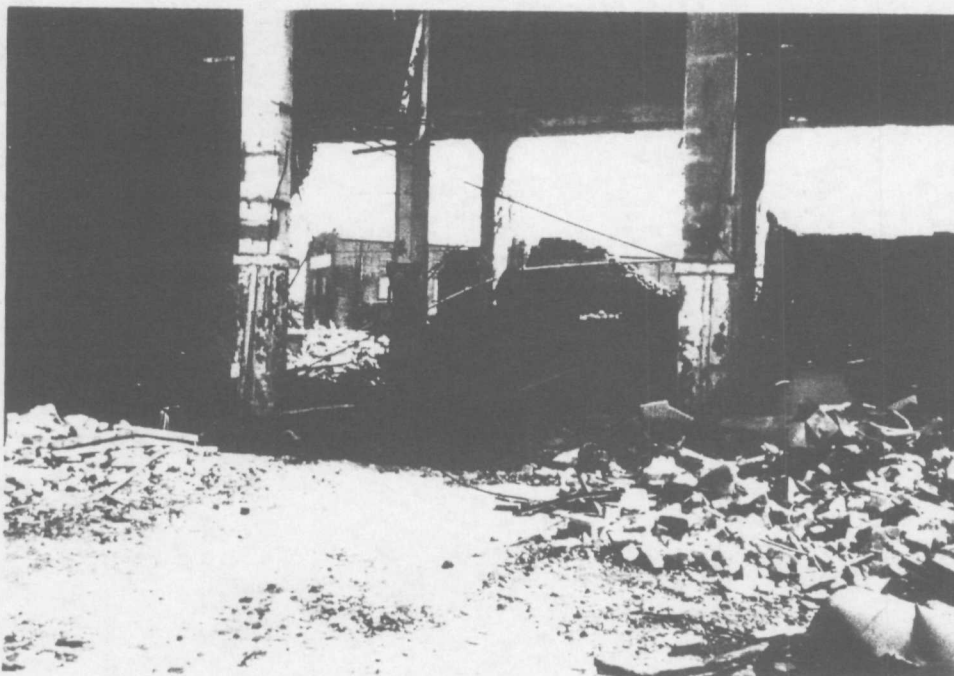
SITE NAME GHR FOUNDRY
 TDD # S05-9604-004
 DATE: APRIL 10 1996
 TIME: 1135
 DIRECTION ENE
 PHOTOGRAPHER LARRY LUECK

SUBJECT: Electrical equipment stored in
 in partially demolished site
 building

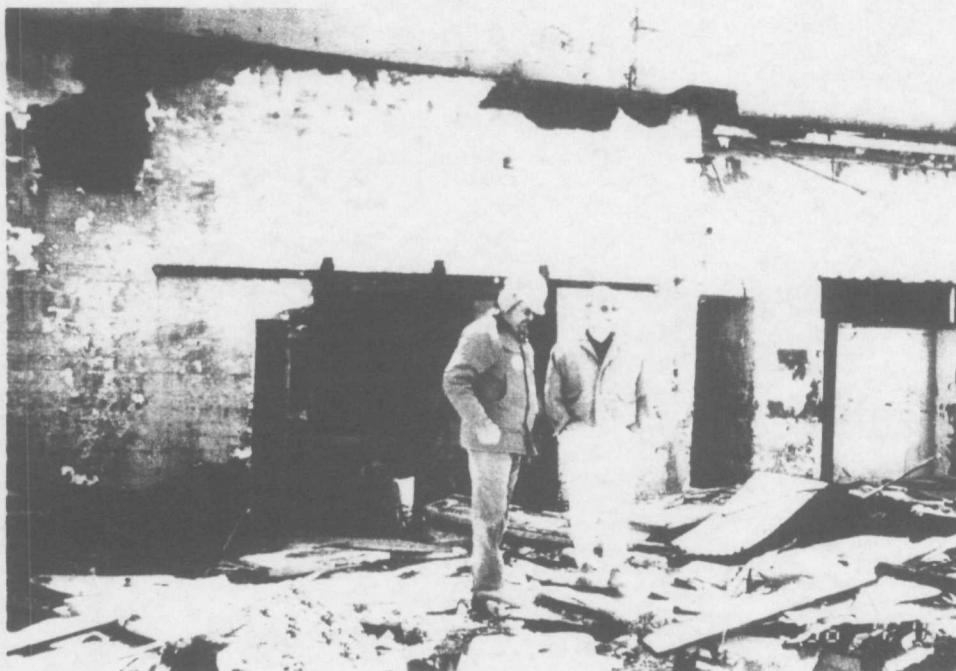
SITE NAME GHR FOUNDRY
 TDD # S05-9604-004
 DATE APRIL 10, 1996
 TIME 1345
 DIRECTION SSW
 PHOTOGRAPHER LARRY LUECK

SUBJECT OSC and OEPA official on rubble outside partially demolished site building; room with tent (r), room with drums, capacitors and asbestos bags (l)

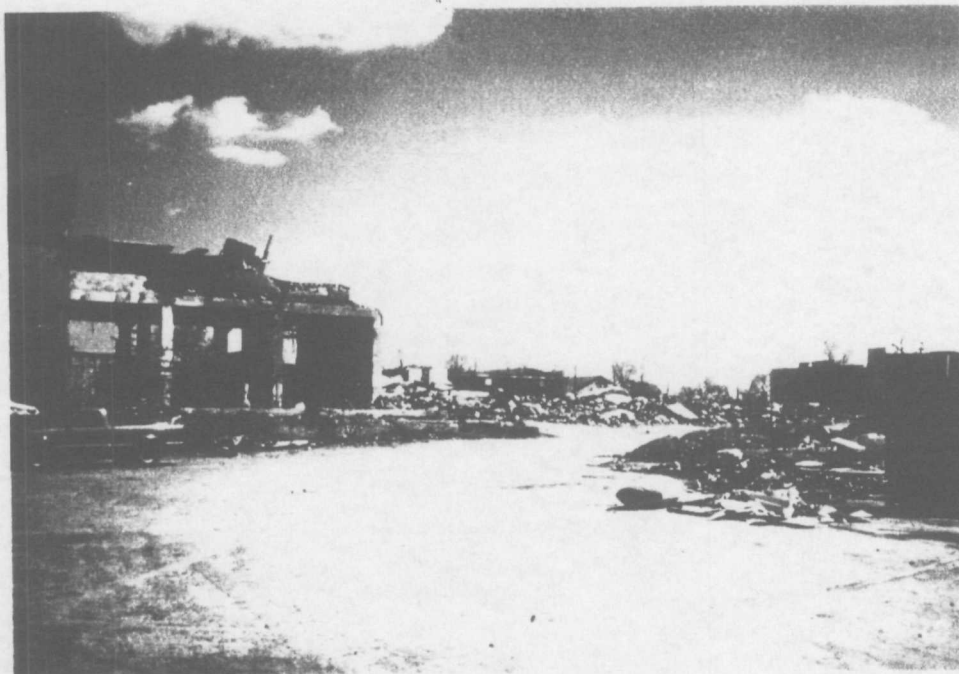
SITE NAME: GHR FOUNDRY
 TDD #: S05-9604-004
 DATE: APRIL 10, 1996
 TIME: 1358
 DIRECTION: SE
 PHOTOGRAPHER: LARRY LUECK

SUBJECT: Partially demolished site building
 and other site building rubble

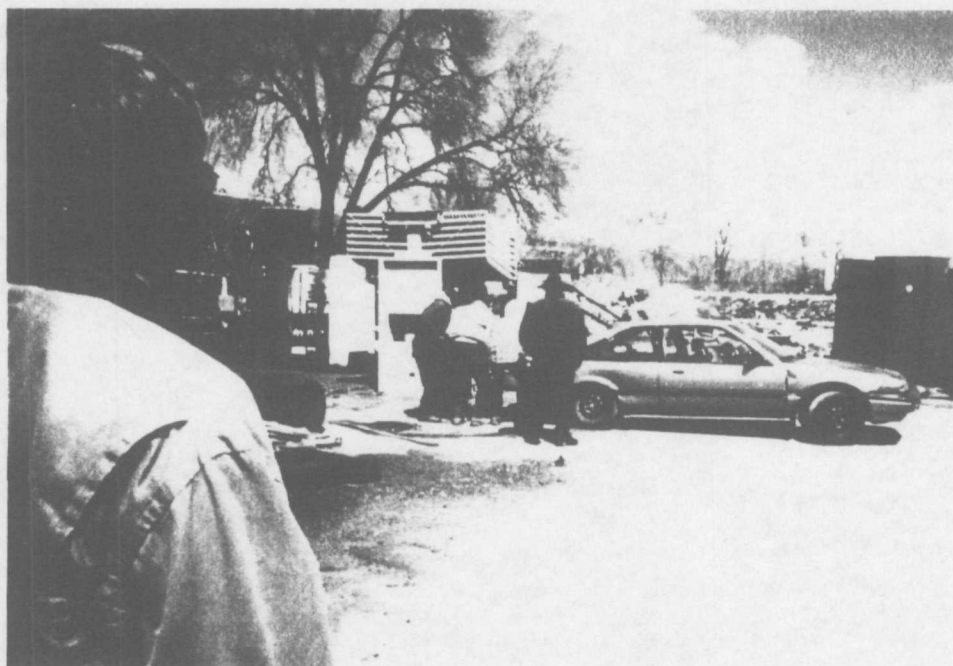
SITE NAME: GHR FOUNDRY
 TDD #: S05-9604-004
 DATE: APRIL 10, 1996
 TIME: 1358
 DIRECTION: WEST
 PHOTOGRAPHER: LARRY LUECK

Several groups of unauthorized scavengers, who were loading cars and pickups with site scrap, appeared to ignore the OSC and START, even when the OSC warned one group that being on this site could prove hazardous to their health. Shortly after U.S. EPA's arrival on site, one of the scavengers evidently tampered with an electrical cabinet standing partway in the access road near the rear end of the brick building, causing the cabinet to spew a thin but continuous stream of clear, amber-colored fluid onto the asphalt.

SUBJECT: Unauthorized scavengers removing staged
 equipment from along site access road:
 leaking electrical cabinet (r)

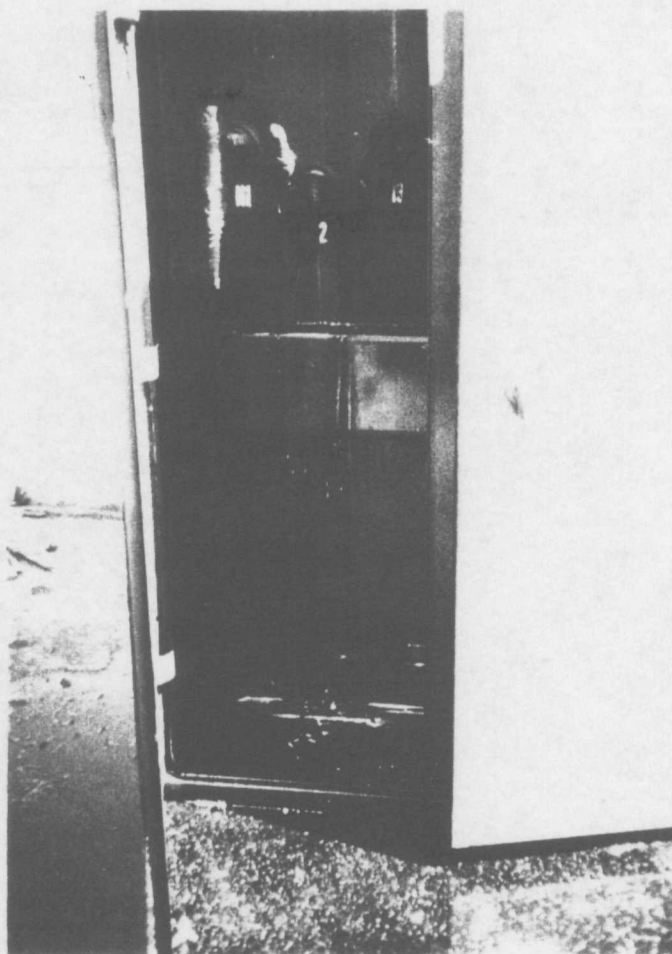
SITE NAME GHR FOUNDRY
 TDD # S05-9604-004
 DATE APRIL 10 1996
 TIME 1430
 DIRECTION SE
 PHOTOGRAPHER LARRY LUECK

SUBJECT Electrical cabinet
 spewing clear oily
 liquid

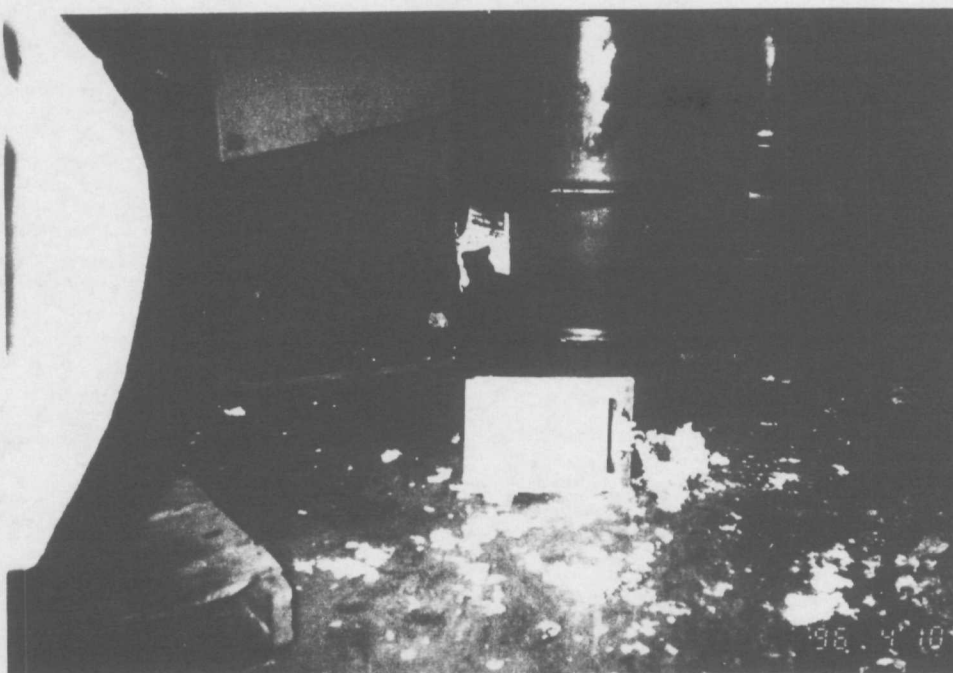
SITE NAME: GHR FOUNDRY
 TDD #: S05-9604-004
 DATE: APRIL 10, 1996
 TIME: 1445
 DIRECTION: SW
 PHOTOGRAPHER: LARRY LUECK

The OSC and START inspected the basement of the brick building, gaining access down a vehicle ramp and through an open garage door. Immediately inside was a forklift, in usable condition, and numerous metal gas cylinders assumed to contain propane for the forklift. Beyond these cylinders was additional stored equipment. The ceiling was coated with fluffy grayish-white material, possibly asbestos insulation, that was falling off in clumps and accumulating on the floor, where it was strewn about.

The analytical results of the samples collected during the GHR Foundry site assessment are presented in Table 4-1. The oil sample and the two soil samples do not contain hazardous levels of PCBs. The ceiling insulation sample, at 25 to 30% Chrysotile asbestos, is above the 1% action level for asbestos, indicating a hazardous condition in the brick building. The validated laboratory reports and quality assurance/quality control memorandum are presented in Appendix B.

SUBJECT: Insulation sample GHR-A-1, inside brick site building.

- 1) Sampling of the contents of drums and electrical equipment for PCBs, flushing of any PCB-containing fluids that may remain in equipment, and off-site disposal of PCB liquids.
- 2) Removal of friable asbestos from the basement ceiling and floor of the brick building and anywhere else it may occur on site. Disposal of asbestos-containing materials and filled asbestos disposal bags at a permitted off-site facility.
- 3) Sampling of the contents of on-site gas cylinders and off site disposal of the cylinders.

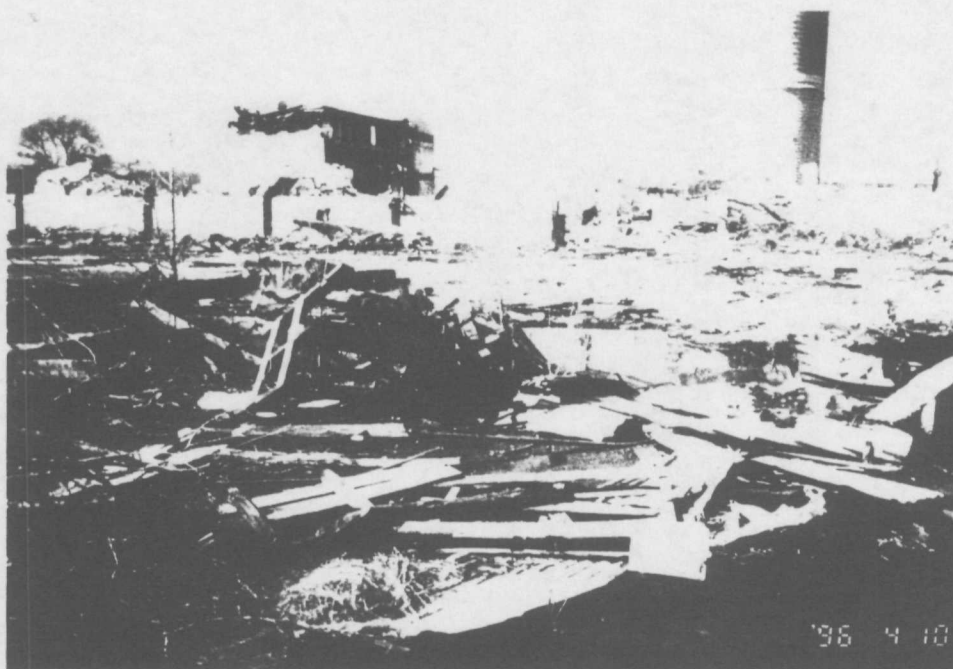
SITE NAME: GHR FOUNDRY
 TDD #: S05-9604-004
 DATE: APRIL 10, 1996
 TIME: 1500
 DIRECTION: N
 PHOTOGRAPHER: LARRY LUECK

SUBJECT: Soil sample GHR-S-2 (in front of placard), perspective; on-site silos and partially demolished site building in background.

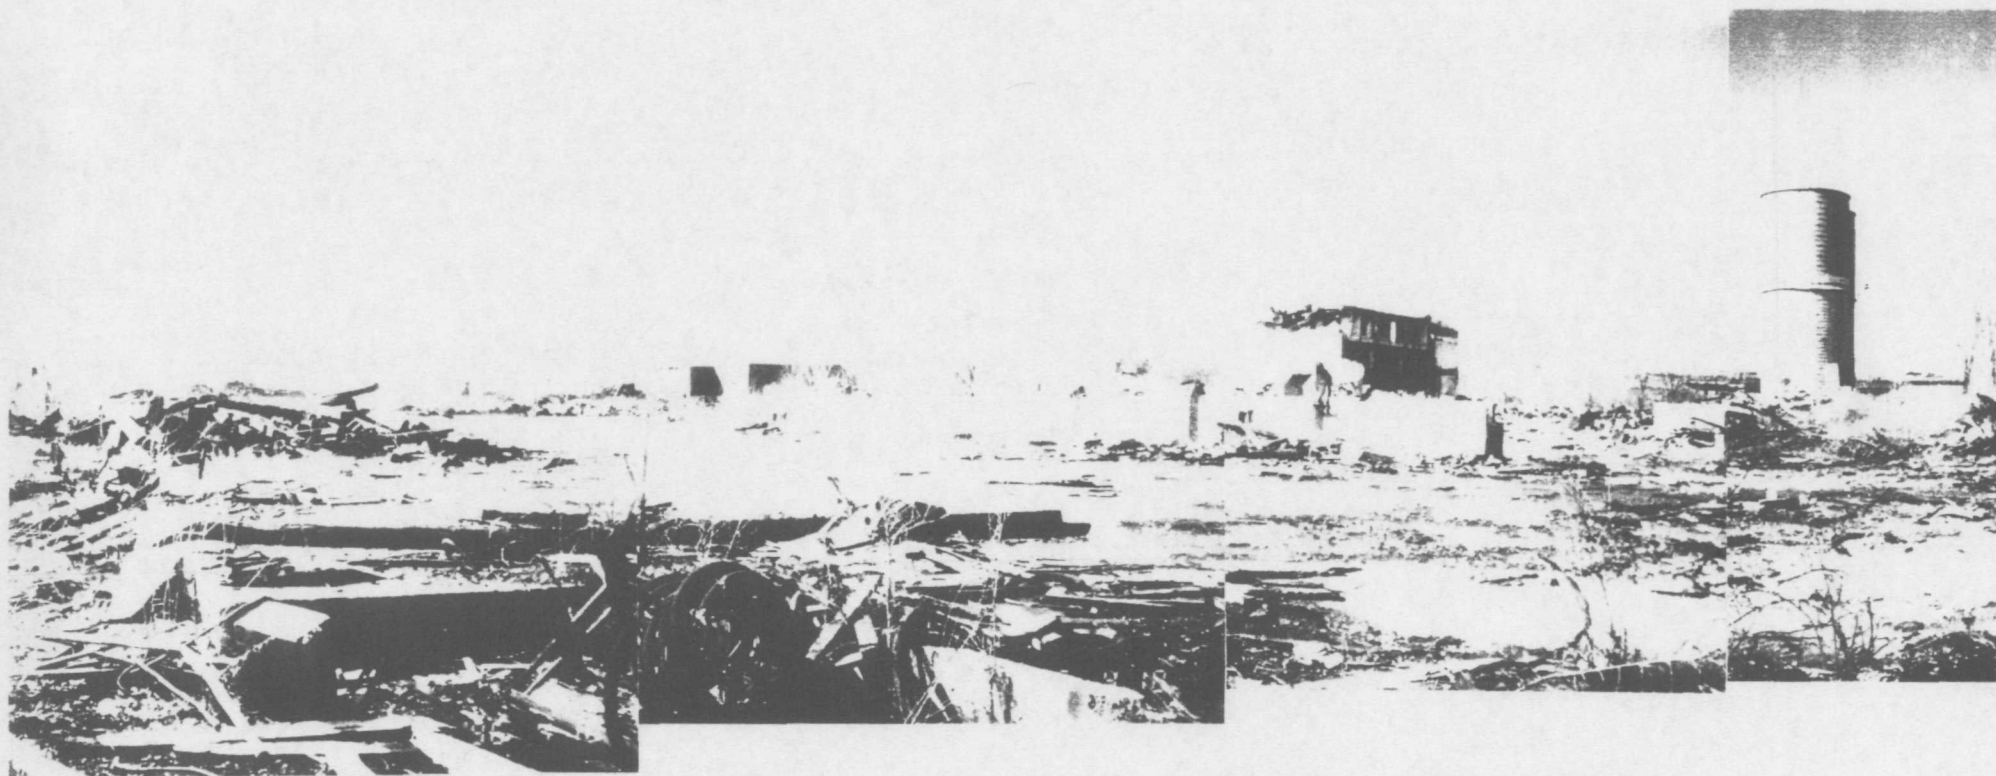
SITE NAME - GHR FOUNDRY
TDD # 505-9604-004
DATE APRIL 10, 1996
TIME 1505
DIRECTION N (r) to W
PHOTOGRAPHER LARRY LUECK

SUBJECT North to west panorama of site photographed
from southeast corner of site.
